Naturally Aged Polymeric Insulators: Washing and its Consequences

Abstract— This paper analyzes the effect of natural saline pollution on polymer insulators that have been aged in the field, and the impact of washing on their performance. Leakage current measurement was the main method used, with infrared radiation detection employed as an auxiliary technique. The 69 kV insulators were in operation for eight years in Porto de Galinhas, in the overhead power lines of the Pernambuco's Electricity Company (CELPE).

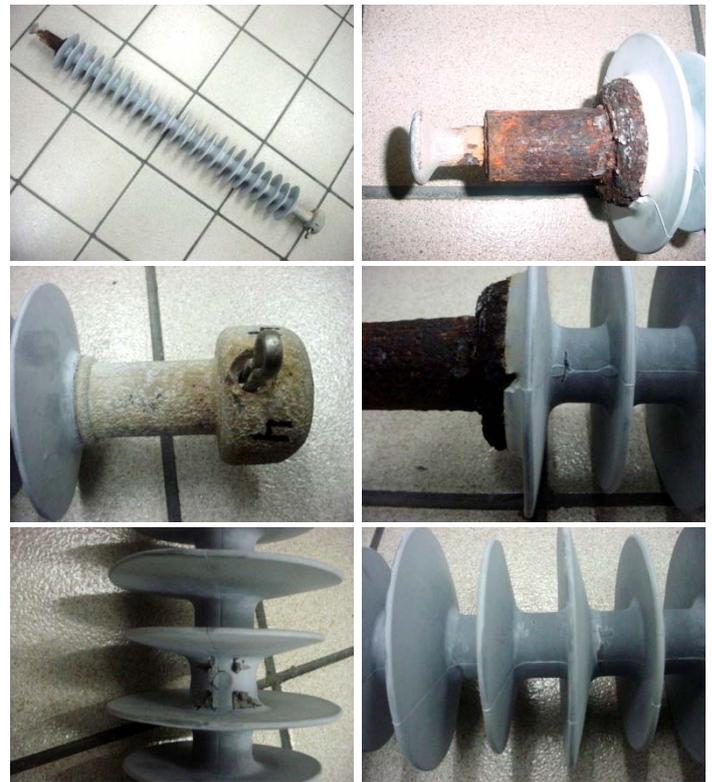
Figure 2. Photos of tested samples.

A visual inspection revealed that all the samples presented small cracks in their polymer sheath, loss of hydrophobicity, and oxidation in the end fitting, especially in the live fitting. The sheds were covered with a white powder. This white powder is possibly a mixture of alumina, a component of the polymer sheath, with the environmental pollution of the region where the insulator was installed.

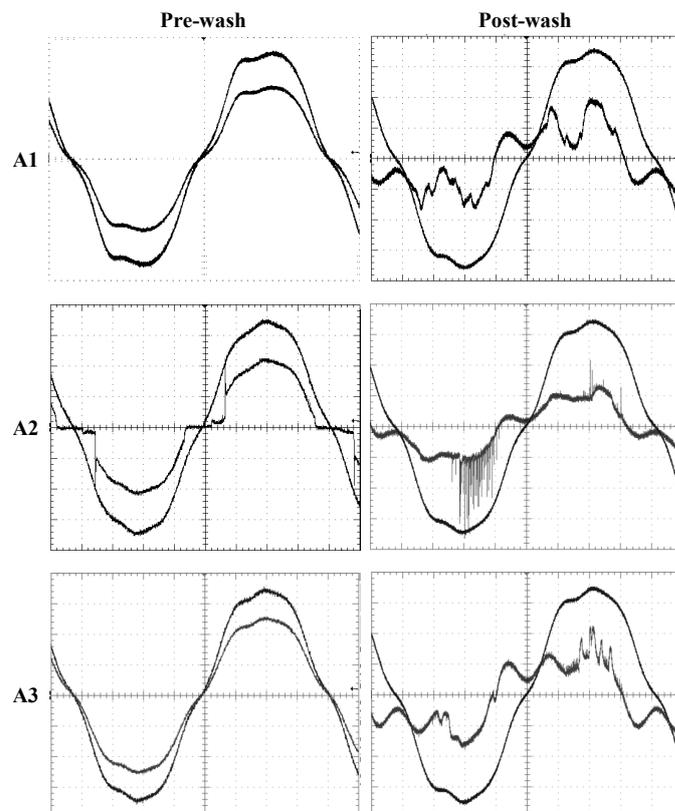
After being washed with a water jet, samples A1 and A3 reduced their leakage currents by 31% and 55%, respectively. The sample A2, washed with a synthetic sponge, presented a reduction of 72% in leakage current, as well as a recovery of hydrophobicity.

Fig. 4 shows the waveform of leakage currents measured during the tests of samples A1, A2 and A3. Observe that corona discharges were intensified after the wash, in spite of leakage current reduction (right column).

Figure 4. Leakage current waveforms of samples A1, A2 and A3, respectively, with pre-and post-wash superficial moisture. Waveforms with the highest maximum values represent voltage signals.

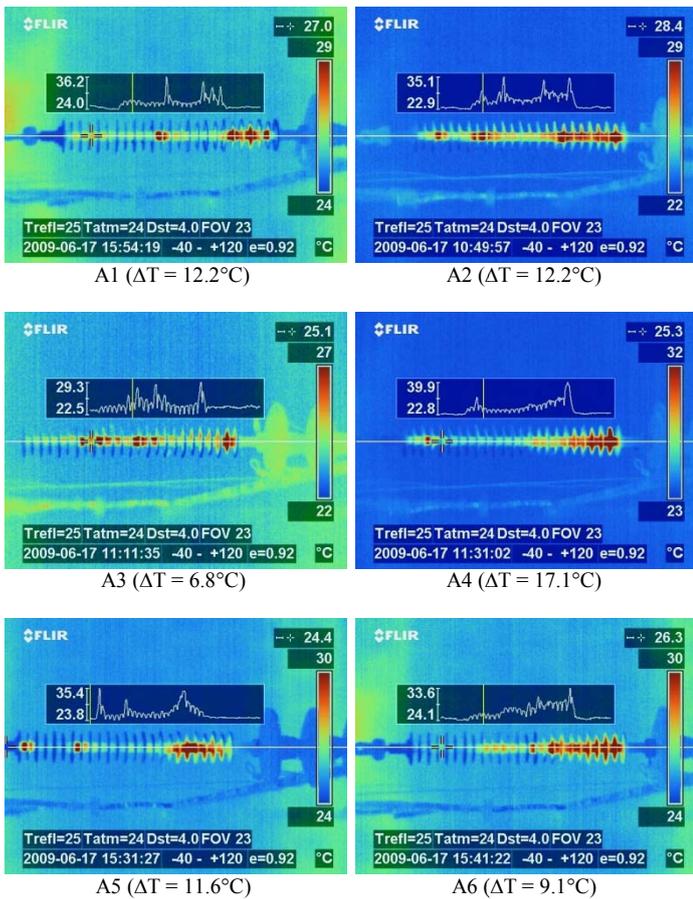
Unequal layers of pollution on the insulators added to different regions of polymer sheath damage produced various thermal profiles.

After applying high voltage, the hottest areas presented intense surface discharge activity, with dry-band formation. After a long period of operation under the action of several degrading factors, the insulator's polymer sheath no longer exhibited acceptable hydrophobicity, causing dry-band arcing.

The regions on the vicinity of the live metallic end fittings had less surface discharge activity. The greater environmental contamination of these areas induces increased surface conductivity and parasite currents, preventing arc formation. These currents, however, cause intense heating, which can also accelerate polymer degradation.

Figure 5. Thermographic profiles of six samples, with natural pollution and elevated superficial moisture (ΔT is the sample's greatest temperature difference).

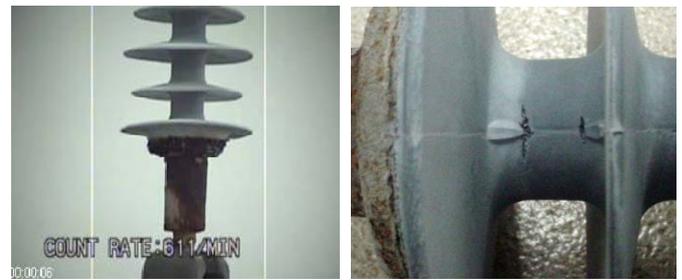
Samples presented practically no corona activity or surface discharges during dry tests (DLCT). Samples A1, A2, A4, A5 and A6 presented occasional corona spots near the live end fitting, which is perfectly normal for equipments in this condition, without equalizing electrodes. Sample A3 had no discharges. For illustrative purposes, Fig. 6(a) shows sample A1 during UV inspection. Since the images of the other samples are practically the same, they are not shown.

Most samples presented little or no discharge activity near the live ending. However, because there was a crack in its polymer sheath in this exact region, sample A5 presented a certain amount of discharge activity. This crack is shown in Fig. 6(b). Each sample presented specific corona points, according to the number of flaws in their polymer sheaths

Figure 6. (a) UV discharge patterns detected during DLCT; (b) Cracks in sample A5's polymer sheath.

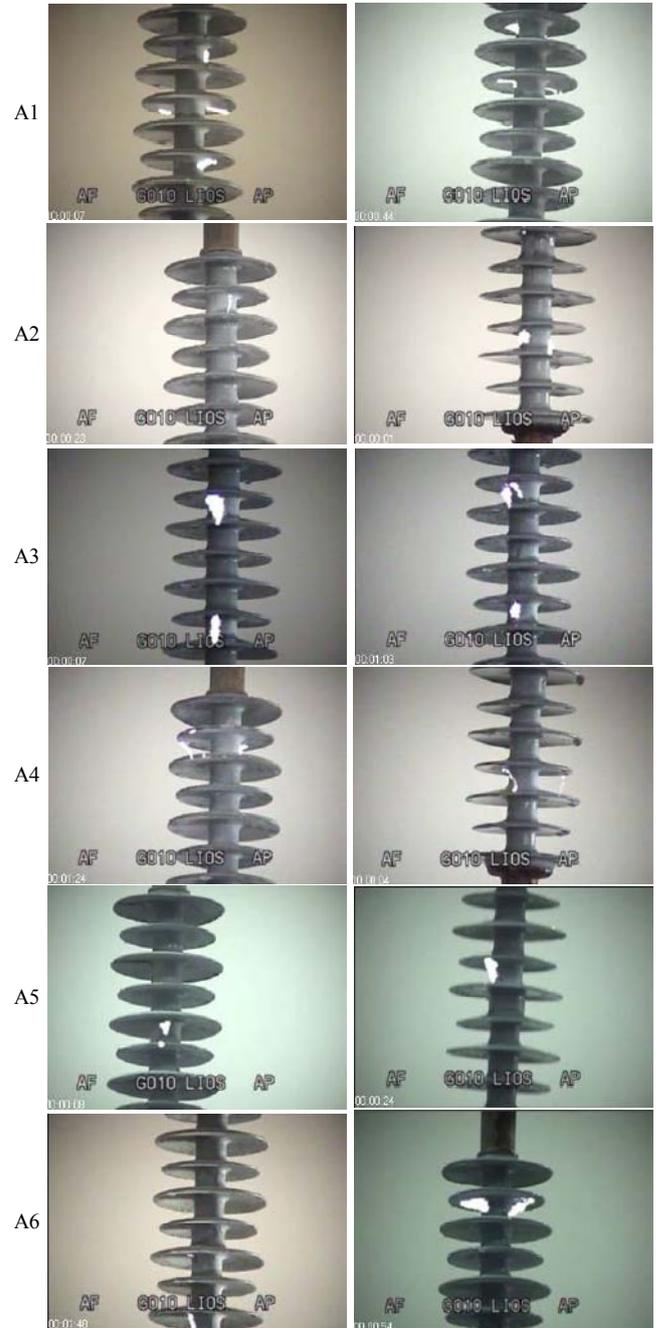
Dry-band formation near grounded endings was detected in all samples in tests with superficial moisture and pollution (WLCT), as shown in Fig. 7. This induced the formation of electric arcs visible to the naked eye, with consequent localized heating, as revealed by infrared inspections.

Figure 7. UV discharge patterns detected during WLCT.

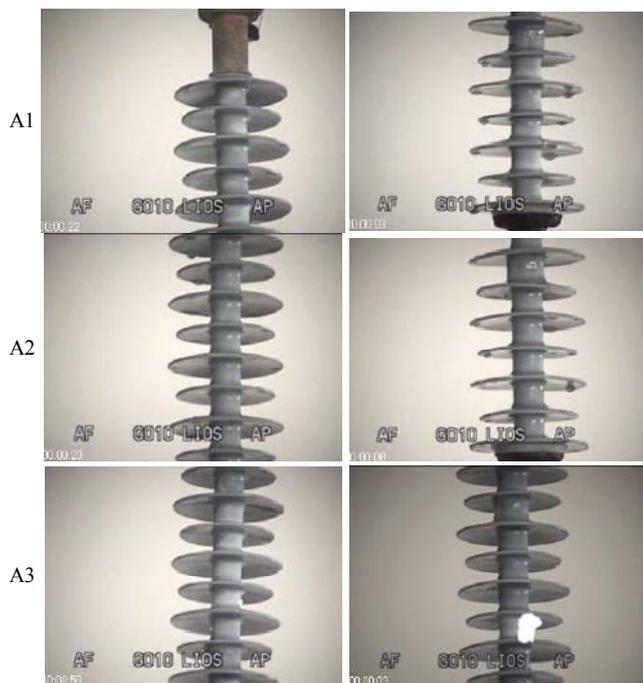
Arc formation was significantly reduced in samples washed with water jets (A1 and A3), as seen in Fig. 8. However, sample A3 still presented a certain amount of arcing. All three samples presented dry-band formation.

Figure 8. UV discharge patterns detected during PWLCT#.
